15th International Conference on Greenhouse Gas Control Technologies, GHGT-15
15th - 18th March 2021 Abu Dhabi, UAE

SaskPower's Boundary Dam Unit 3 Carbon Capture Facility - The Journey to Achieving Reliability

Stavroula Giannaris^a, Dominika Janowczyk^a, Jonathan Ruffini^b, Keith Hill^b,

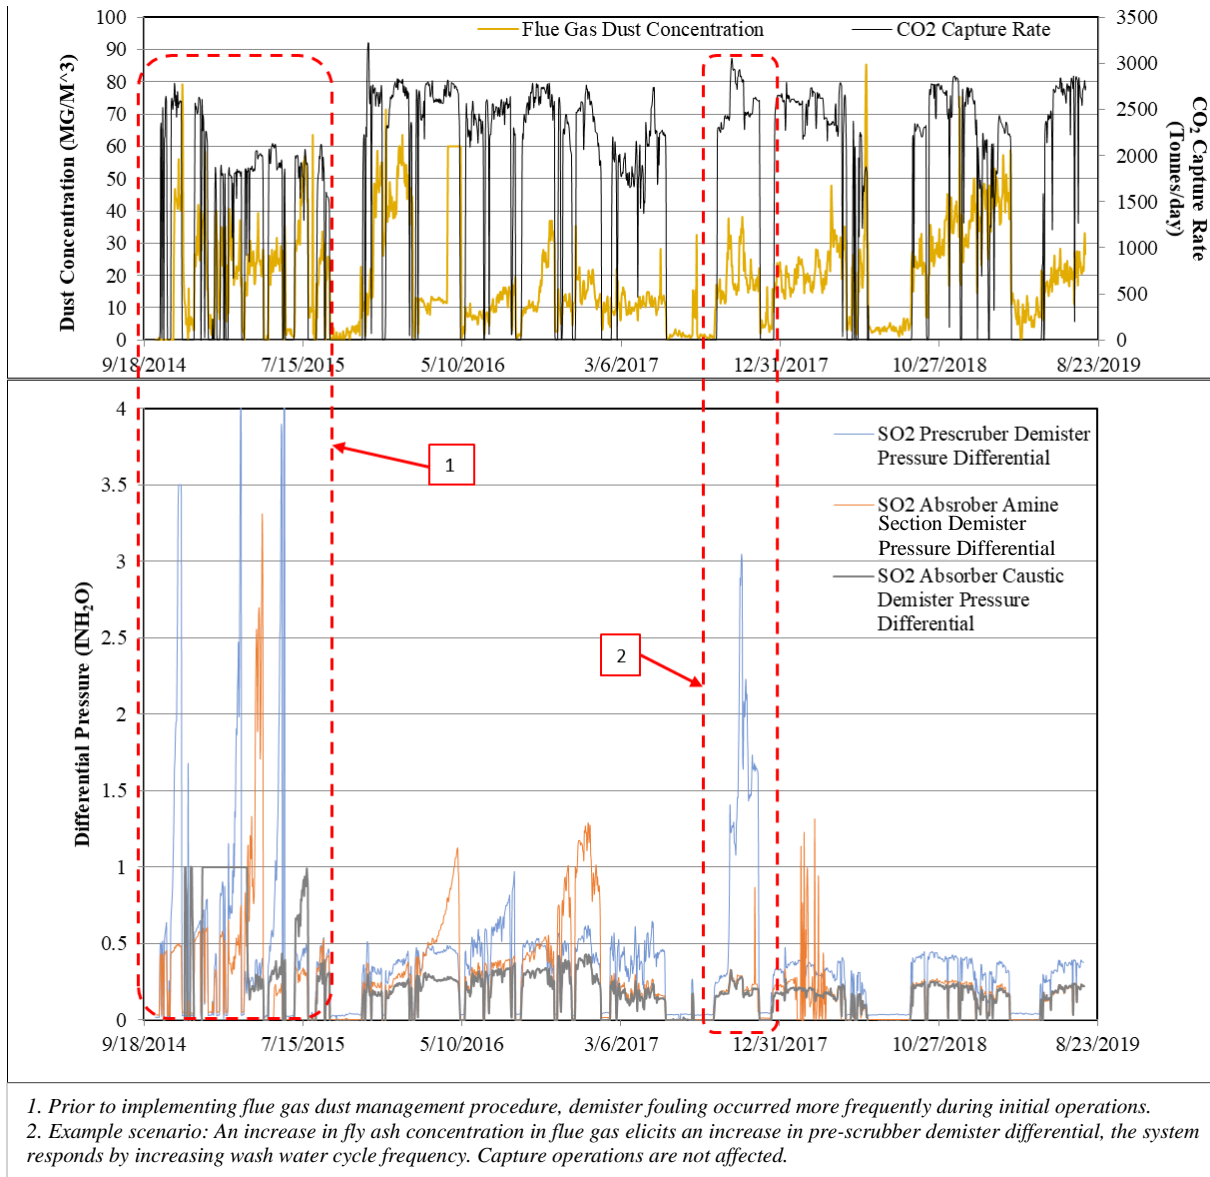
Demisters are used to prevent carryover and contamination between different liquid sections and are designed to prevent liquid from penetrating through them. The SO₂ absorber has three sections of demisters. The prescrubber demister is a section just above the prescrubber section of the SO₂ absorber that is designed to prevent carryover contamination of any liquid droplets from the prescrubber section into the SO₂ amine section. The amine section is also equipped with a demister system to prevent amine losses through liquid entrainment to the caustic section. A third set of demisters in the caustic section prevents the carryover of caustic wash solution to the CO₂ absorber. Fly ash would plug off the prescrubber demisters approximately every six to eight weeks. This would lead to significant increases in differential pressures across the prescrubber demisters to the point that the booster fan could no longer physically overcome the pressure drop while the induced draft fans at Unit 3 would begin to max out. This would inhibit the amount of flue gas passing through the SO₂ absorber (and subsequently the CO₂ absorber) resulting in overall reduced CO₂ capture rates (as demonstrated in scenario 1 of Fig. 7). The other two sets of demisters fouled, although less frequently, with the amine section demisters fouling every six months while the caustic wash section demisters fouled approximately every 12 to 18 months. The original design included bottom sprays for the demister systems which would spray intermittently every 15 minutes. These would prove to be inadequate. Top sprays were added to the prescrubber demisters in 2015 to combat fly ash plugging issues. Top sprays were then also added to the amine and caustic section demisters in 2017. The occurrence of increased differential pressures across the SO₂ absorber demisters has been reduced (as demonstrated in Fig. 7).

Fig. 7 Example of how demister wash systems mitigate losses in CO₂ capture rates

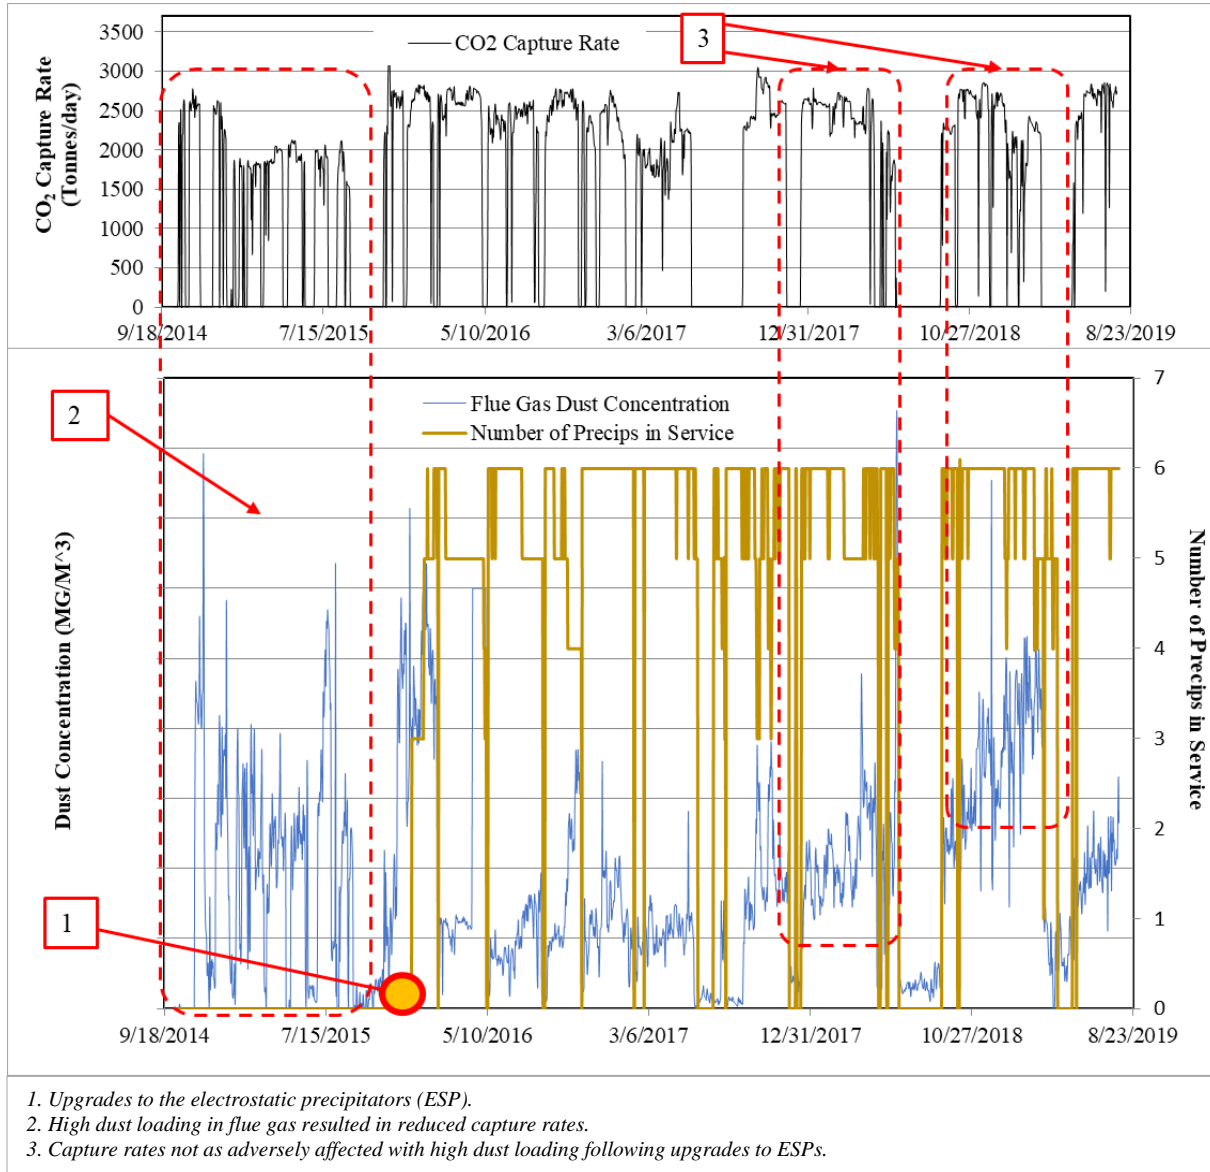
smallest of particles bypass these systems. Fly ash was identified as a main contributor to reduced CO₂ capture rates (as demonstrated in scenario 2 in Fig. 8). This prompted upgrades to be made to the ESPs. Switch Integrated Rectifiers (SIRs) were added in late 2015/early 2016. These upgrades aided in managing flue gas dust concentration. Although dust concentration increases from time to time (as dust concentration is highly dependent upon the ash content of the coal, among other things), the combination of these upgrades with the addition of the various wash spray systems limits the severity of reduced CO₂ capture performance resulting from fly ash ingress (as demonstrated in scenario 3 in Fig. 8).

Fig. 8 Affects of dust loading in flue gas on capture rates

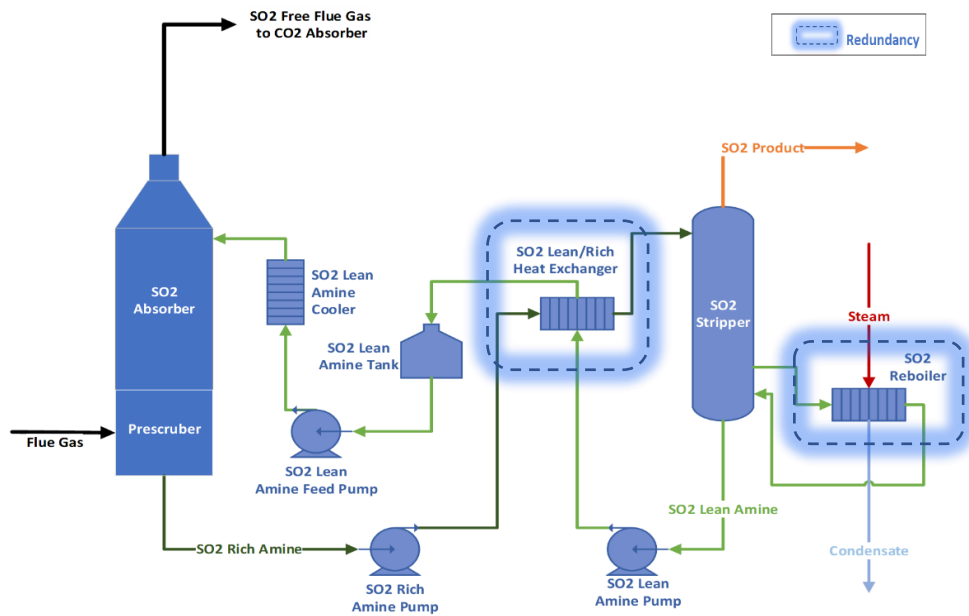
The SO₂ reboiler experienced scale build up which was attributed to particulate matter (fly ash) that had entered the SO₂ capture system. This scale acted as an insulator and prevented heat transfer between the steam and the amine which subsequently hindered the regeneration of the rich SO₂ amine and reduced the efficiency of the SO₂ removal system. Although the addition of wash spray systems did reduce the incidence of fly ash carryover, fouling of the SO₂ reboiler continued to persist, requiring an outage every three to four months of the entire capture facility in order to chemically clean the reboiler. A second redundant reboiler with double block and bleed valves was installed in June of 2017 to mitigate this issue by allowing online maintenance and continued operations by swapping between the two heat exchangers as required. The SO₂ lean/rich heat exchanger also experienced fouling which was detected by monitoring increased pressure differentials across both the rich and lean sides. The lean side however exhibited far greater pressure differentials. Sulphate formation was discovered to occur during the amine regeneration process demonstrating that sulphate plugging uniquely affects only the lean side of the lean/rich heat exchanger. To counter this, a second, identical, redundant SO₂ lean/rich heat exchanger was installed. Fig. 9 illustrates which heat exchangers received corrections within the SO₂ capture processes.

Fig. 9. Locations of added redundancy to key heat exchanger system in the SO₂ capture system

| Heat Exchanger System | Corrective Action |
|---|--|
| SO ₂ Lean/rich | Added redundant exchanger and double block and bleed isolations |
| SO ₂ Reboiler | Added redundant exchanger and double block and bleed isolations |

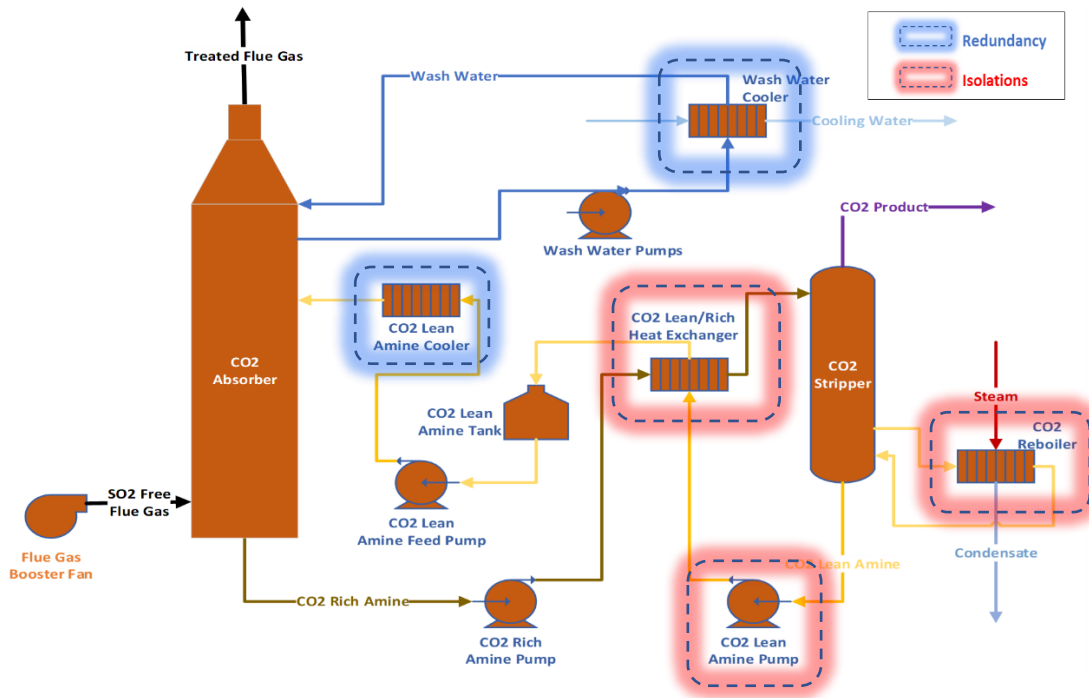
gas before the processed flue gas exists to the atmosphere. Effectiveness of this wash water system is dependent on keeping the temperature of the wash water cool. The original design of this system included a single cooler. Fouling of this cooler hindered its ability to deliver consistent and adequate cooling; struggles were encountered in maintaining wash water temperatures. The CO₂ capture process cannot operate without a wash water cooler as this would result in amine emissions out the top of the absorber which is not permissible. To rectify this, a second wash water cooler was added in parallel to the original cooler. This provided better control over cooling and also compensated for any fouling issues. Double-block and bleed valves were also installed to allow isolation of each cooler for on-line maintenance as necessary.

Difficulties in cooling were also encountered with the CO₂ lean amine cooler. Once again, the original design included a single heat exchanger for this purpose. Adequate cooling of the lean amine prior to its re-entry to the absorber tower was not being provided. This meant that the lean amine was entering the absorber tower at higher than anticipated temperatures. This interfered with the water balance of the system and required the addition of demineralized water to maintain the desired concentration of the amine. The high temperatures also reduced the CO₂ amine's ability to adsorb CO₂ from the flue gas, resulting in a slight decrease in CO₂ capture performance. Hydraulics modeling was completed which suggested that the lean amine cooler was not receiving sufficient flow and that additional cooling capacity would help achieve the desired amine temperatures. A second lean amine cooler was installed in February of 2017. Isolations were included with this second cooler and were also added to the existing cooler. Once the second lean amine cooler was placed into service the original cooler was isolated for on-line servicing. Scaling was discovered on the amine side of the original lean amine cooler which is thought to have contributed to the issues in performance. Fig. 10 illustrates which heat exchangers received corrections within the CO₂ capture processes.

Fig. 10. Locations of added redundancy and isolation to key heat exchanger system in the CO₂ capture system

| Heat Exchanger System | Corrective Action |
|---|--|
| CO ₂ Lean Amine Cooler | Added redundant exchanger and double block and bleed isolations |
| CO ₂ Wash Water Cooler | Added redundant exchanger and double block and bleed isolations |

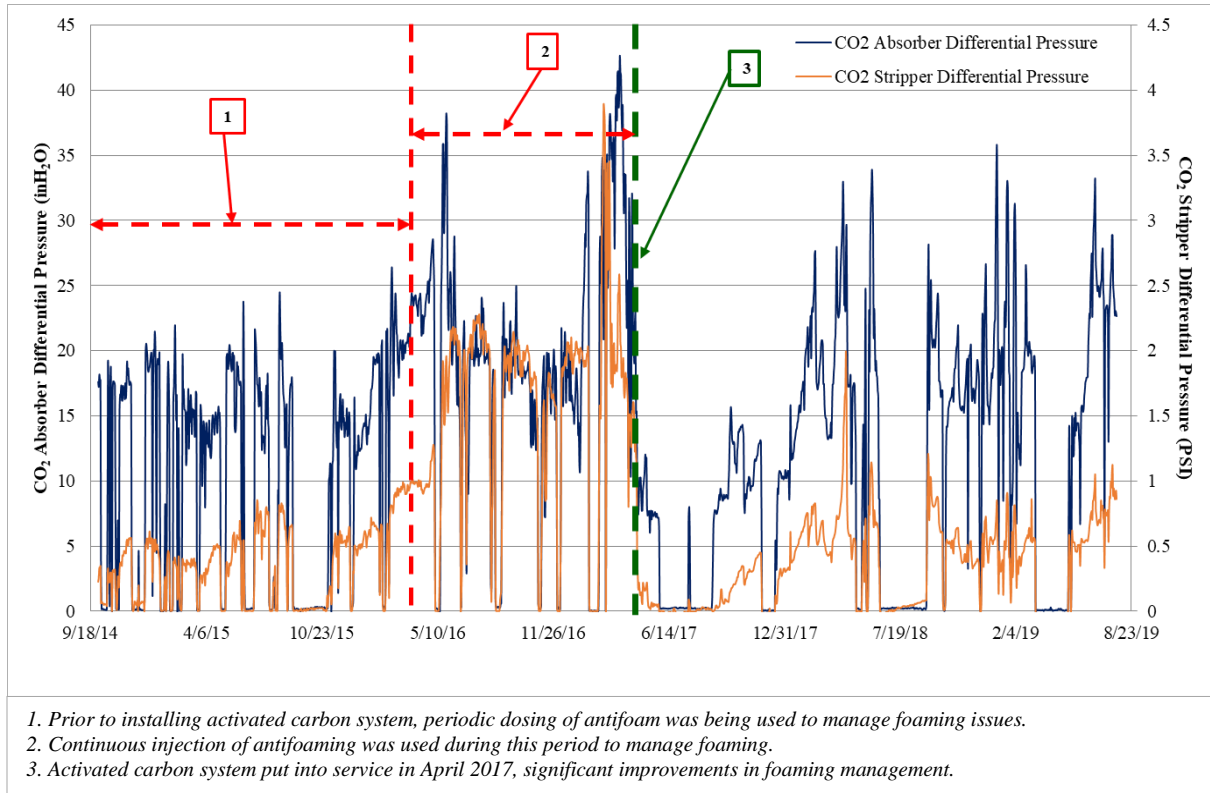
The initial onset of foaming at the CCS facility at BD3 was after the 2015 fall outage. Foaming was experienced in both the CO₂ absorber and CO₂ stripper columns. Foaming was detected through increased pressure drops across the structured packing in the stripper and absorber towers. In the absorber column, foam interferes with the mass transfer and thus limits the amount of CO₂ the amine can absorb. In the stripper column, foaming limits the ability for the steam to transfer its energy to the rich amine in order to effectively strip off the captured CO₂. During and following the fall outage, it was determined that thermal reclamation would be conducted on the amine to remove an assumed build-up of degradation products. This reclamation was conducted onsite using a contracted reclaiming system on a period basis in the Fall 2015. With continuous system cleaning, reduction of foaming was observed although the issue persisted.

Fig. 11 Example of foaming indicative differential pressures in the absorber and stripper towers

Antifoam was then sought after to manage foaming; continuous antifoam injection began in April 2016. Bigger volumes of antifoam were periodically dosed into the CO₂ amine which lowered the foaming tendencies of the solvent. The cost of the antifoaming agent, however, was great. Signs of instability of the system operation due to the antifoam were also observed. Another issue was related to determining the amount of antifoam in the system as excessive antifoam can potentially cause foaming. In February 2017, CO₂ stripper packing damage caused by the instability of the system from antifoam was discovered on a small section of bed 1. During the June 2017 outage, damage was also observed in the packing further up the column. Damaged packing in the affected beds was replaced in July of 2017. Antifoam use was put on hold and was not used again until December 2020.

An activated carbon filtration system was then trialed to mitigate foaming. Activated carbon filters have been used for removal of dissolved organic contaminants in amines utilizing an adsorption unit or "filter" utilizing granular activated carbon. Activated carbon filters operate more effectively at lower temperatures. In April 2017 a smaller pilot scale of this system would be implemented on the lean side of the CO₂ amine, upstream of the CO₂ absorber. The pilot proved to be successful in its effectiveness at relatively low cost. An added benefit of activated carbon is to remove excess antifoaming agents from the amine. During the Spring 2017 outage, the system was appropriately sized to be a full-scale pilot size processing roughly 2% of the CO₂ amine stream. Replacing the defoaming agent with an activated carbon unit worked well from the May 2017 to October 2017 (as illustrated in Fig. 11) however levels of foaming gradually increased over time. Today foaming continues to persist. It is not currently clear whether the root cause is related to fouling and exhaustion of the activated carbon, inadequacy of the volume of the slip stream being processed through the activated carbon or other process changes. Investigations into this matter continue.
