15th International Conference on Greenhouse Gas Control Technologies, GHGT-15
15th - 18th March 2021 Abu Dhabi, UAE

SaskPower's Boundary Dam Unit 3 Carbon Capture Facility - The Journey to Achieving Reliability

Stavroula Giannaris^a, Dominika Janowczyk^a, Jonathan Ruffini^b, Keith Hill^b,

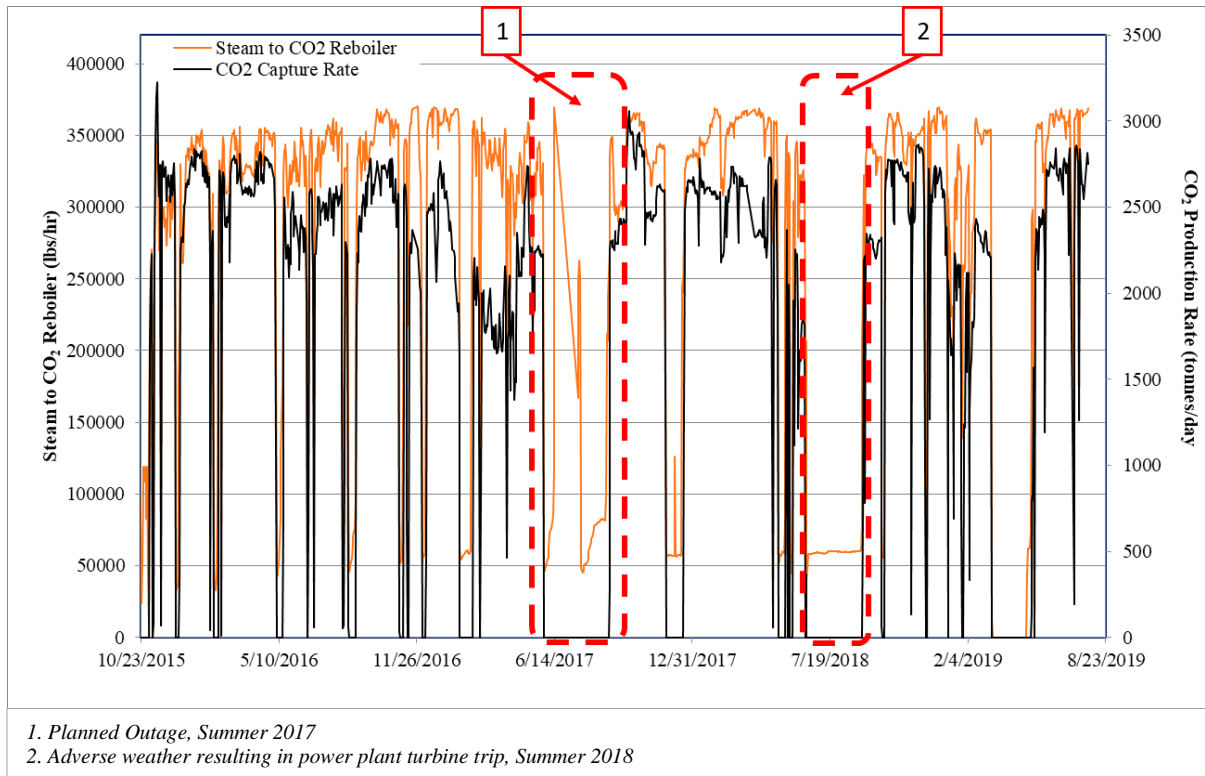
Fig. 6 Comparing steam supply to the CO₂ reboiler and CO₂ capture rate

The BD3 CCS project comprised of two distinct sub projects: 1) modifications to the existing power plant to enable the turbine steam extraction which would supply the regeneration energy and 2) building the capture plant. The fully integrated design between power plant and capture plant has worked well. The steam extraction from the turbine has been reliable, as illustrated in Fig. 6, and has not shown to be a main contributor to decreased CO₂ capture.
